**THREATS TO MARINE TURTLES
IN THINES KIPARISSIAS BAY
(GREECE)**

REPORT BY ARCHELON

**ANTHROPOGENIC DISTURBANCES AT THE NESTING AREA OF *CARETTA CARETTA*
IN SOUTHERN KYPARISSIA BAY
(NATURA 2000 - GR2550005)**

**Short report submitted to
the European Commission and the Standing Committee of the Bern Convention
Athens, October 2012**

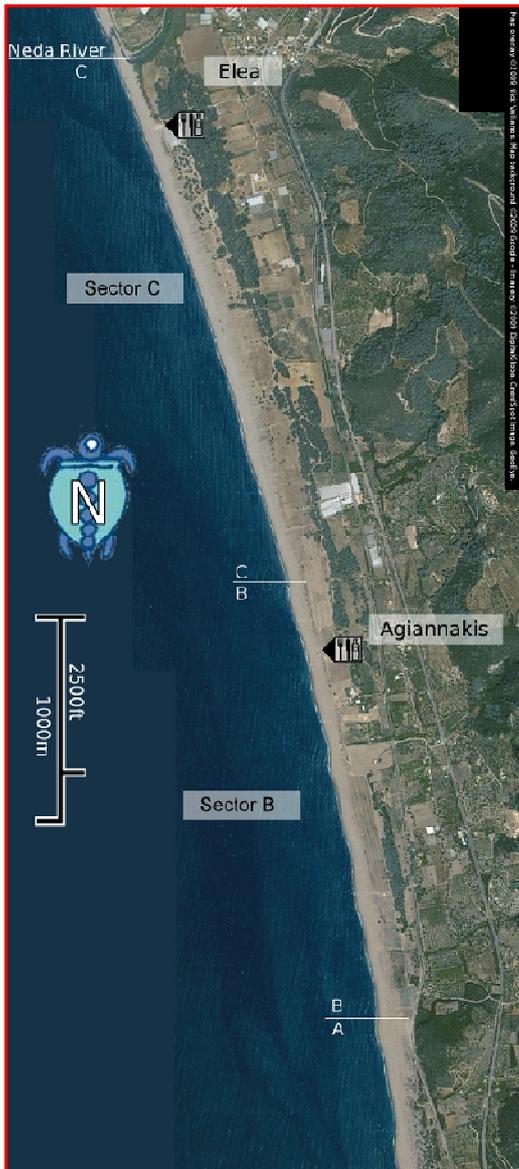
Illustration 3: North part of Southern Kyparissia Bay

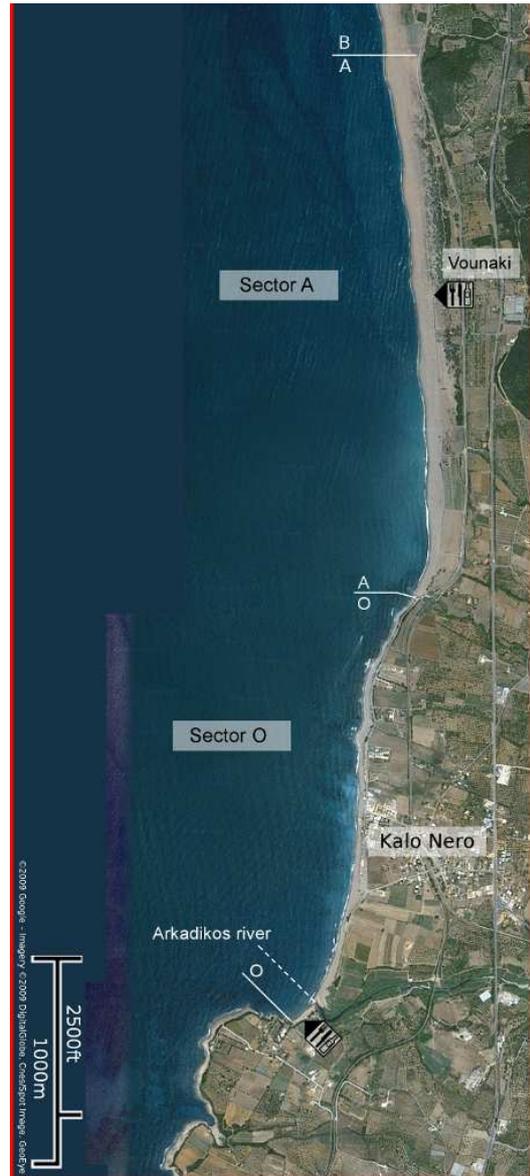
Illustration 4: Continued from Illustration 3. The southern half of the monitored area of Southern Kyparissia Bay includes sector O, largely backed by the beach front of Kalo Nero

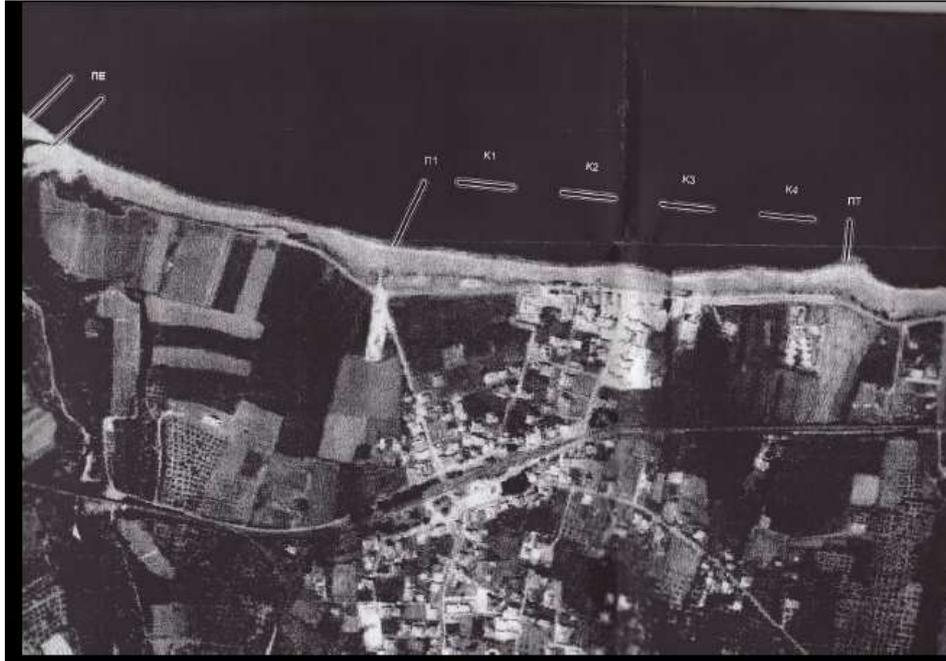
Illustration 5: The 4 -above the surface of the sea- wave breakers.

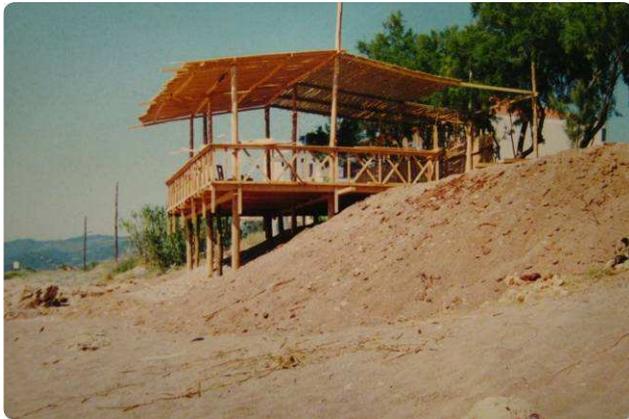
In addition to the road, elevated platforms used as beach bars and restaurants started appearing on the back of the beach since 1994 (Photo 1). These were constructed and used as extensions by restaurants and bars that opened on the landward side of the road. In recent years, these platforms were leased out by the Municipality under the guise of “simple beach use.”

Picture 1: The first beach platform to appear in Kalo Nero, in 1994. (DM)

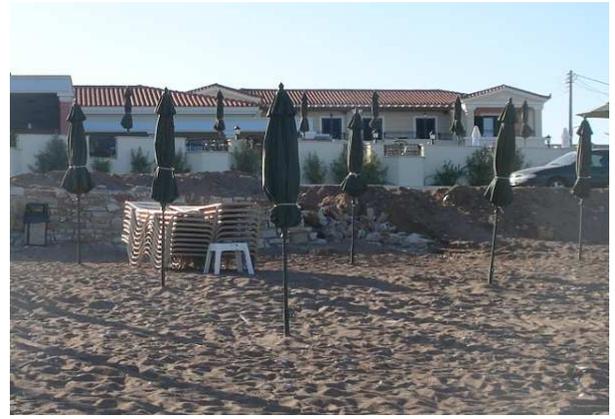
On 28 December 2006, the Coast Guard of Kyparissia arrested eight workers who were constructing a concrete wall on the back of the beach. The wall was intended to protect the platforms from wave action during the winter but also created space for new platforms (Photo 2). The former Mayor of Avlona, whose term ran out at the end of 2006, was taken to court for authorizing unlicensed construction. On 3 January 2007 the new Mayor continued the construction and was also taken to court. By the summer of 2007, a significant part of the wall had been constructed.

Picture 2: A new wall was constructed on the back of the beach

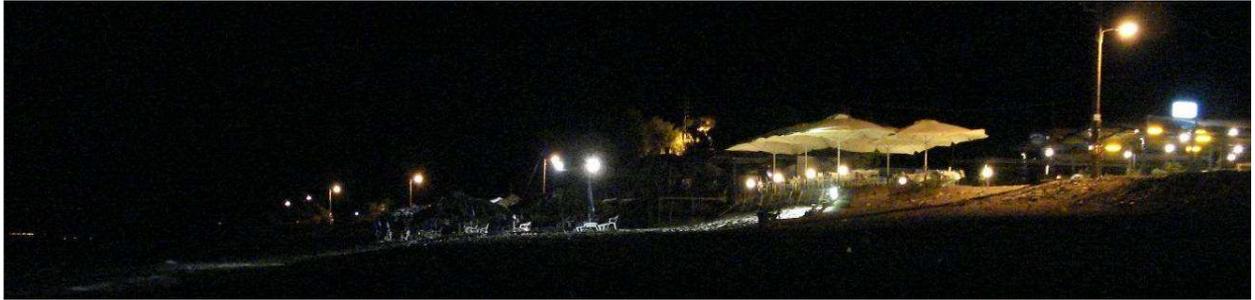
Street lights are installed on electricity poles along the road on the beach front of Kalo Nero. The lights hang from a height of five to seven metres and most are uncovered from all sides. The bulbs are commonly fluorescent white, with lighting power equivalent to roughly 200 watts. Most street lights are very close to the beach, i.e. within 10m from the back of the beach. Additional light pollution is caused by hotels, restaurants and bars on beach platforms, spot lights shining right on the beach, and lights from parked camper vans (Photo 3).

Picture 3: Light pollution in Kalo Nero is severe. Lights from a restaurant on the right, street lamps, platforms and spot lights on the beach turn night into day. It is nearly impossible for hatchlings to find the sea in this area.

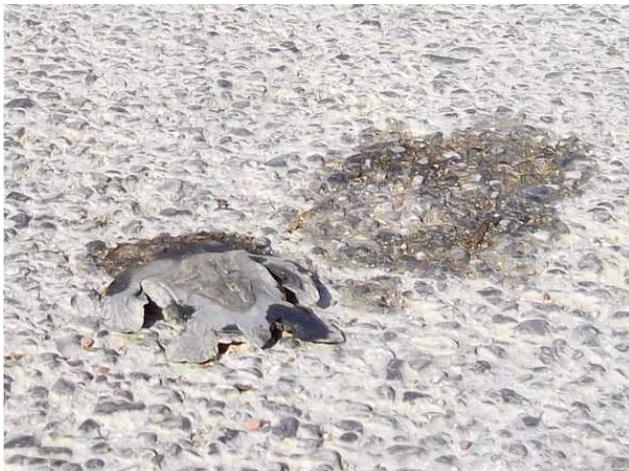
It is not uncommon for hatchlings to be found on this coastal road during the night by ARCHELON volunteers, visitors or locals. Very few are rescued and returned to the beach. Some hatchlings are found squashed by cars or dead by exhaustion and dehydration (Photo 4). Most hatchlings are never found; only their tracks heading towards the back of the beach are discovered during the morning survey.

Picture 4: This hatchling followed the brightest light to make it to the sea, but made it to the road instead.

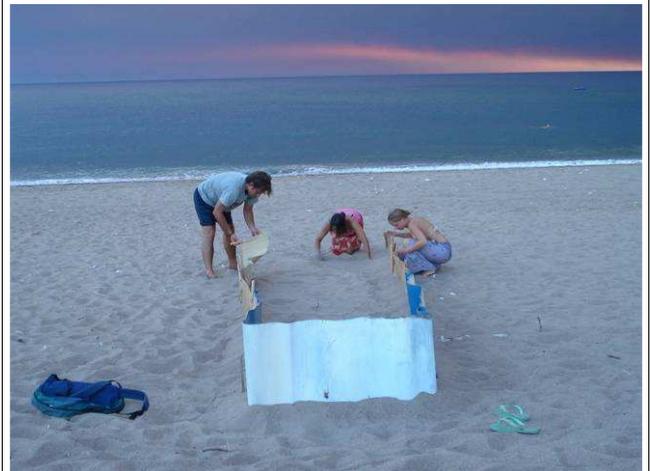
Picture 5: Volunteers install shading on a nest.

A common method, used routinely by ARCHELON, to prevent hatchling disorientation is to “shade” a nest, in the vicinity of intense lights, so that artificial light does not reach it directly (Photo 5). However, the problem of light pollution is so intense in Kalo Nero that the simple shading of nests is not effective. This is so because light comes from above and it is very bright because of the proximity and the height of street lights which produce severe light pollution in such a way that some hatchlings although have managed to enter the sea they come out again and move towards the lights.

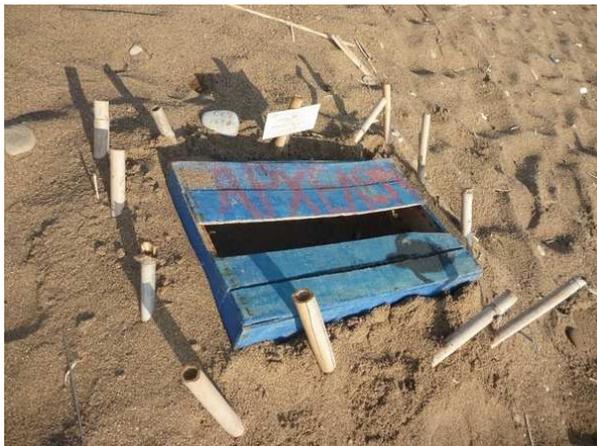
Picture 6: A box is placed over the nest during the night to trap emerging hatchlings.

In order to overcome this severe problem, ARCHELON found necessary to monitor the nests in this section throughout the night in an attempt to reduce the loss of hatchlings due to light pollution. Nests which are expected to or are known to be hatching are covered with a box during the night so that emerging hatchlings are unable to move away (Photo 6). The boxes are checked at regular intervals and all hatchlings found are released on the back of the beach at a dark location, so that they can make it to the sea. In the last years more than 50% of all nests in Kalo Nero have had to be boxed. Thousands of hatchlings are rescued through “boxing” each year, but this is nevertheless an unorthodox method. The problem of light pollution can and needs to be solved at its root.

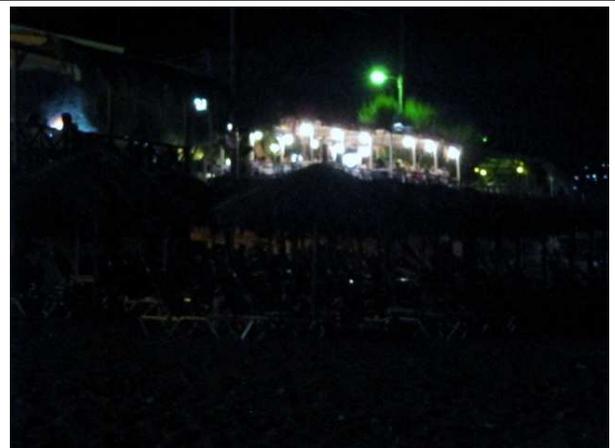
In the area of Kalo Nero, much of the beach in front of beach platforms is leased for simple beach use, but sunbeds are not removed during the night (Photo 7a). In many occasions, the beach structure is manipulated and wooden paths, showers, and other structures are added on the sand. This makes a significant part of the beach inaccessible to sea turtles, while the few nests that are successfully laid are in danger of direct or indirect damage (Photo 7b).

Picture 7a: Beach furniture is not removed during the night (photo by Panagiota Theodorou).

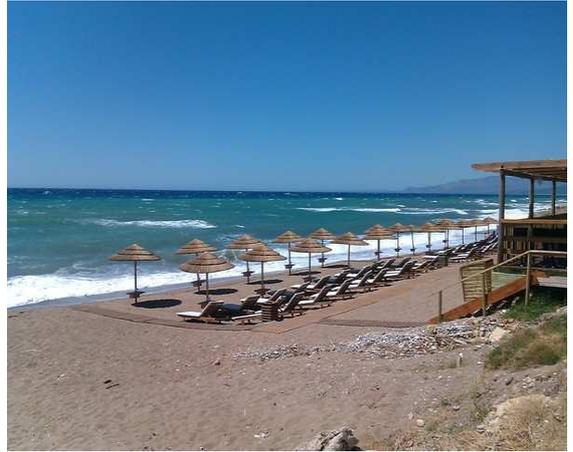
Picture 7b: Simple beach use in Kalo Nero excludes the area used from sea turtle nesting. The few nests that are laid here risk being damaged.

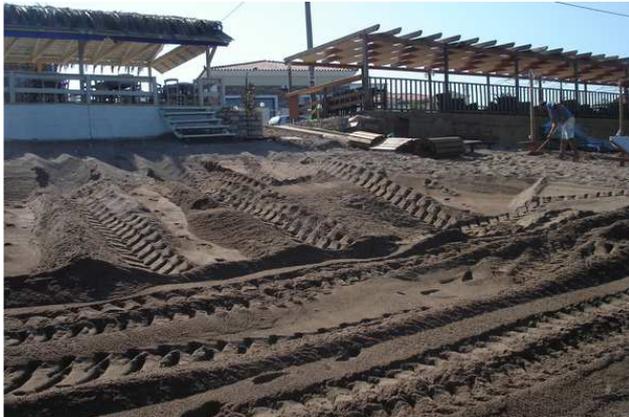
beaches is prohibited from 1 May until 31 October. Although nests were marked, heavy machinery on the beach cause vibrations in the sand and damage nearby nests, potentially causing hatchlings to emerge early. They also alter the beach structure by compacting the sand, and removing pebbles to make the beach more pleasant for beach users (Photo 8).

Picture 8: Heavy machinery on the beach (photo by Daisy Parsons).

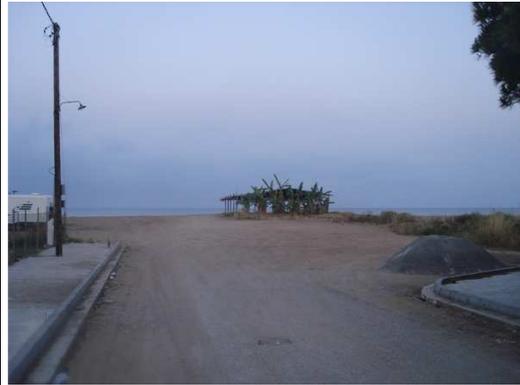
Picture 9: The road leading to the beach of Elea in 2007. All sand dune vegetation has been removed and the sand has been mixed with soil to be used as a car parking area.

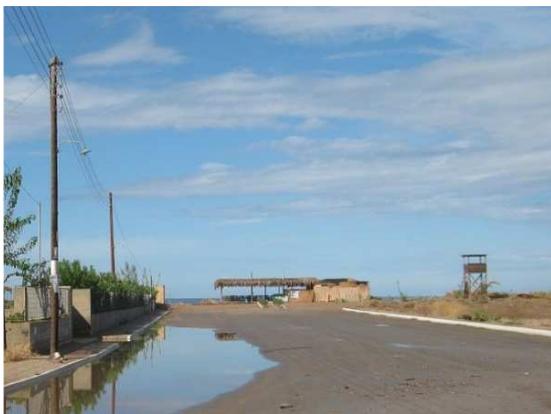
Picture 10: The road access to the beach of Agiannakis was asphalted in 2009. It serves as a parking area. Street lamps installed here affect hatchlings from hundreds of metres away.

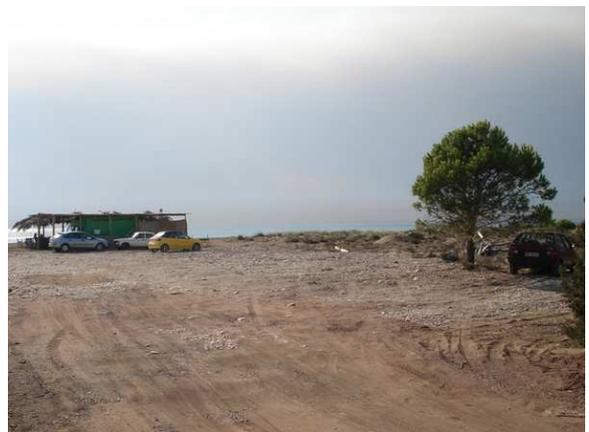
Picture 11: The road leading to the beach bar of Vounaki. Dune vegetation was removed, and the sand was layered over with stones and soil for easier access.

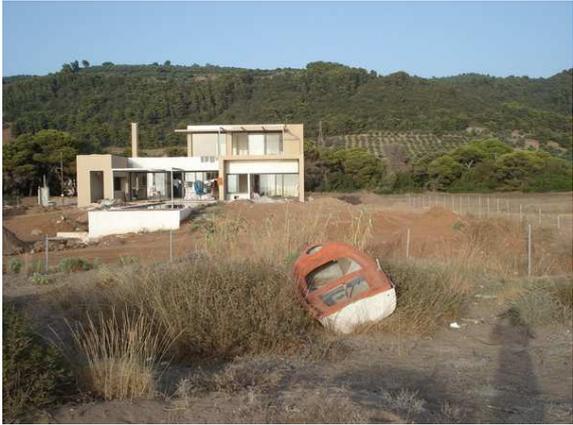
Picture 12: A new house was built within the core area.

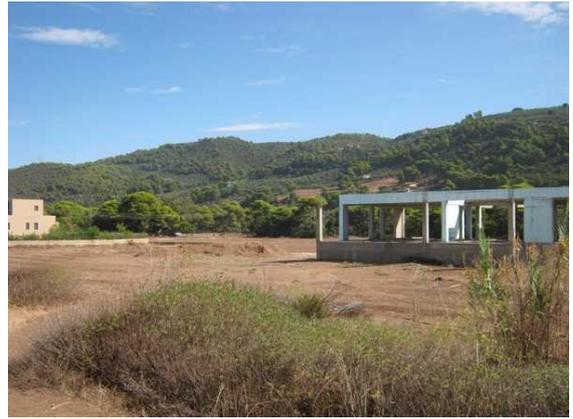
Picture 13: A new house construction began behind the beach in 2010 but has now ceased.

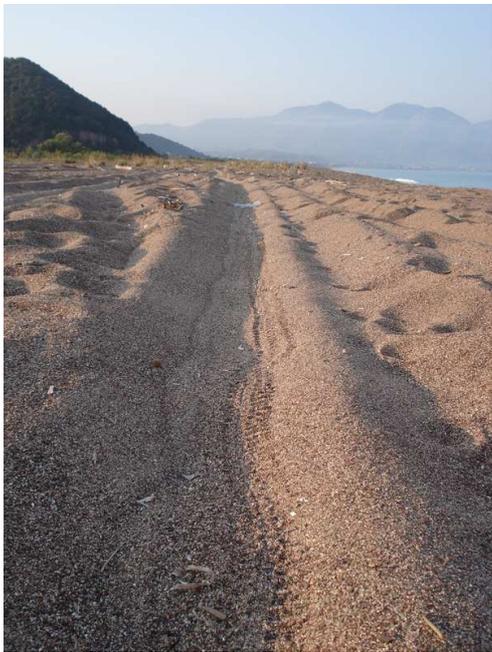
Picture 14: Hatchlings can crawl inside car tracks for hundreds of metres.

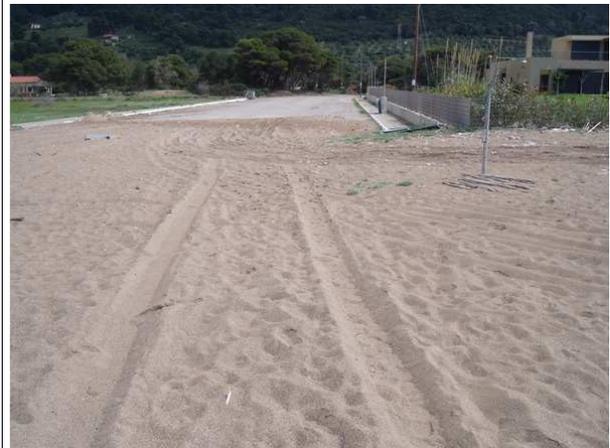
Vehicles moving on the beach also cause damage to the sand structure and dune vegetation. On all entrances to the beach, sand dune vegetation is absent and the dunes are lower than surrounding dunes (Photo 15). In addition, regular movement of vehicles has created a permanent track on the sand dunes along the entire beach (Photo 16).

Picture 15: Dune vegetation is absent from entrances to the beach, making it susceptible to erosion.

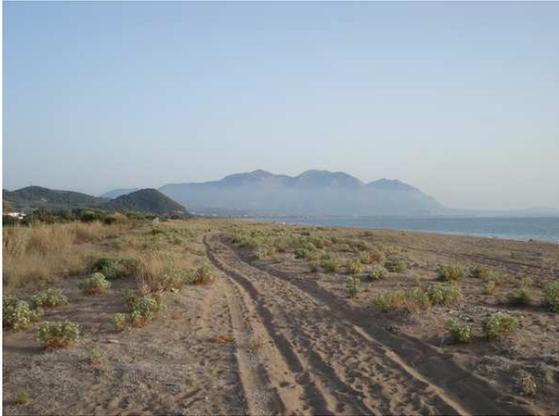
Picture 16: Regular movement of vehicles has created a permanent track on the sand dunes.

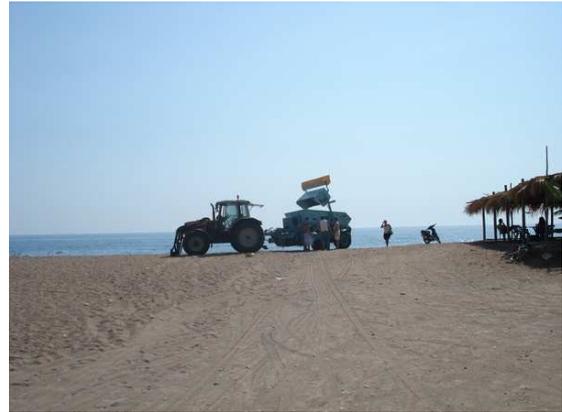
Since 2007, the Municipality of Avlona has often employed heavy machinery to clean large portions of the beach from debris that has washed up during the previous winter. The machines used filter the sand and remove large and small debris as well as a large number of stones. This changes the sand structure and can add to beach erosion. The vibrations of these heavy machines can cause damage to sea turtle nests and potentially cause hatchlings to emerge early (Photo 17).

Picture 17: Heavy machinery is used for beach cleaning

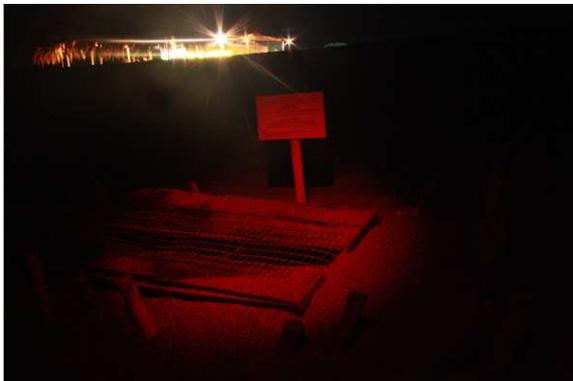
Picture 18: This nest near the beach bar of Vounaki had to be boxed to save the hatchlings from certain disorientation (photo by Jeffrey Ho).

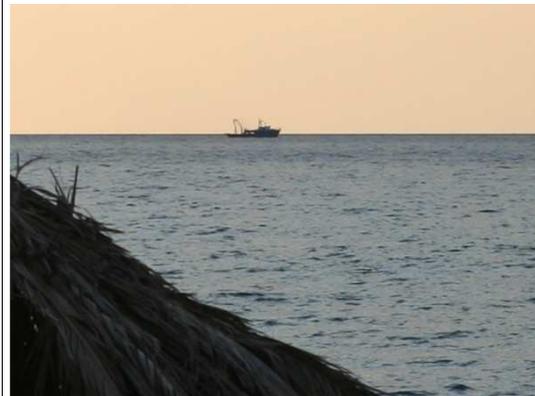
Trawling vessels are recorded almost daily in the Bay of Kyparissia, especially in May. The fishing activity in May coincides with the arrival of sea turtles for the nesting season. These vessels move at a close distance to the coast, often at a south to north direction (Photo 19).

Picture 19: A trawler is fishing at a short distance to the beach of Southern Kyparissia Bay, October 2011 (photo by Hannah O'Mahoney).

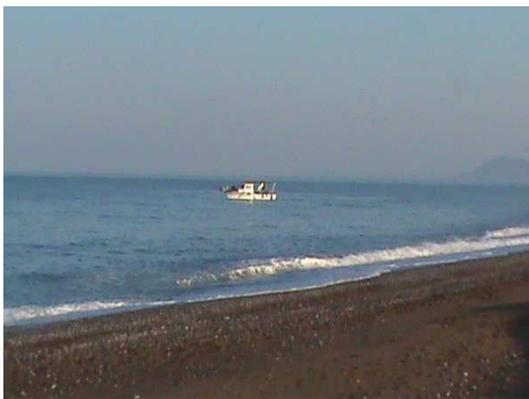
Small fishing boats based in the harbour of Kyparissia regularly deploy gill nets close to the nesting beaches of southern Kyparissia Bay. The nets are placed in late evening and collected in early morning. Most nets are used within 1km from the beach (Photo 20).

Picture 20: Artisanal fishing with gill nets near the beach is a danger to sea turtles moving in the area and attempting to nest, as well as to hatchlings entering the sea (photo by Aris Gkintidis).

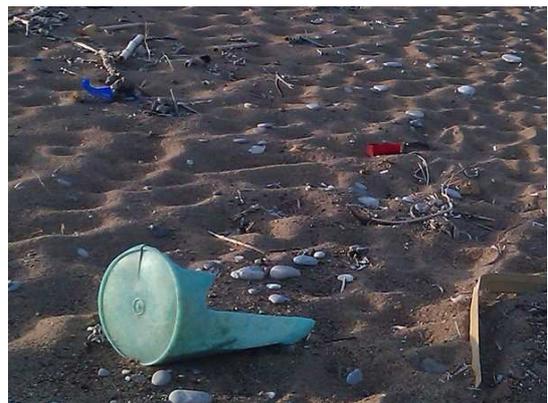
Southern Bay of Kyparissia is littered with a large number of items of marine debris. Most of them are washed out of the sea during high wave activity and gradually buried in the sand or return to the sea (Photo 21). Plastic sheet discarded after use in local agriculture are also found. A similar pattern of uniform debris density is witnessed in the shallow waters of the Bay.

Picture 21: Marine debris, commonly plastic waste, is widespread on the beaches of Southern Kyparissia Bay.

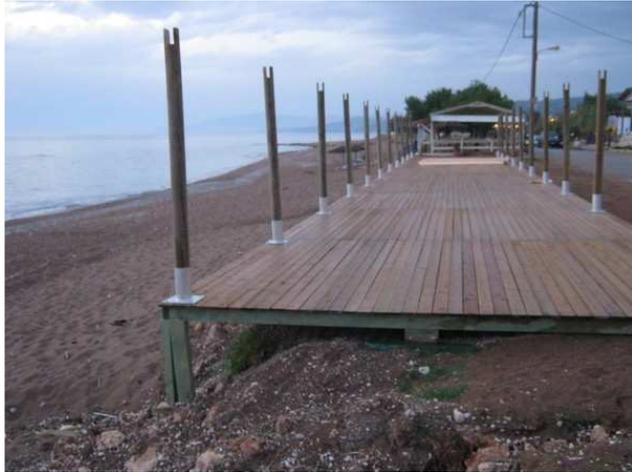
Picture 22: A new platform on the beach of Kalo Nero appeared in May 2011.

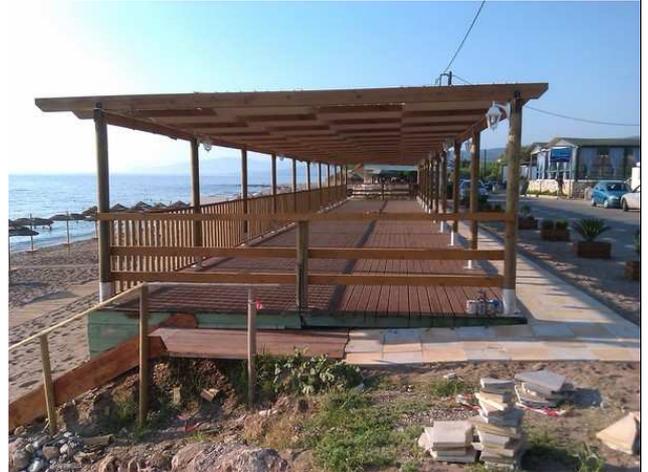
It must be noted that the platform is based on the wall built illegally on the beach in 2006/2007 and that the platform and objects placed on the beach by the same hotel violate several clauses of the Joint Ministerial Agreement that prescribes “simple beach use”.

Picture 23: Legal action by the Coast Guard, the Police, the Public Land authority, and the Planning authority had no effect. Despite having no legal basis, the platform was complete and operational by July 2011.

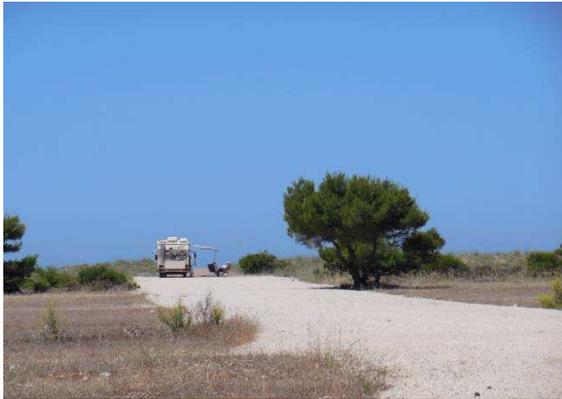
Picture 24: The end of all illegal roads is used as parking areas which causes further flattening of the dunes.

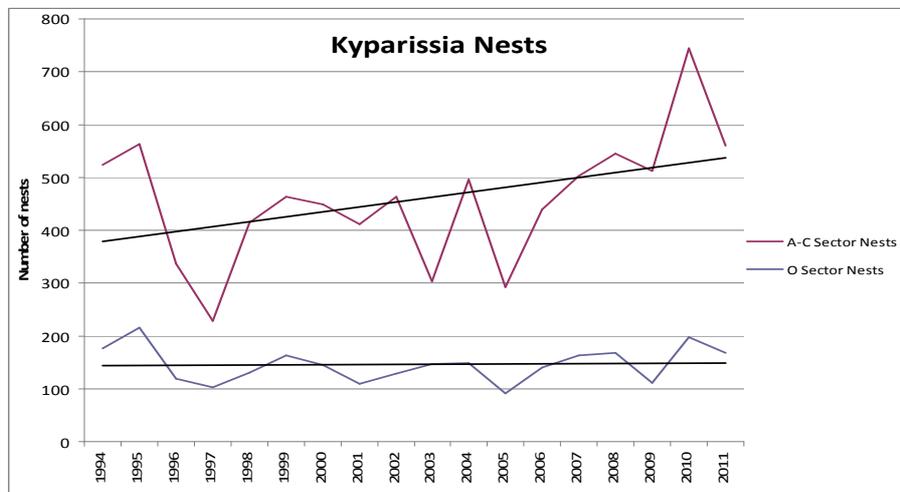
Nevertheless, the observed increase of nests observed in the three sectors (A-C) does not appear in Sector O which exhibits a great increase of anthropogenic disturbances over these years (Graphs 1 and 2).

Graph 1. Evolution of nesting in sectors A-C and O showing trend lines over the years 1994-2011.

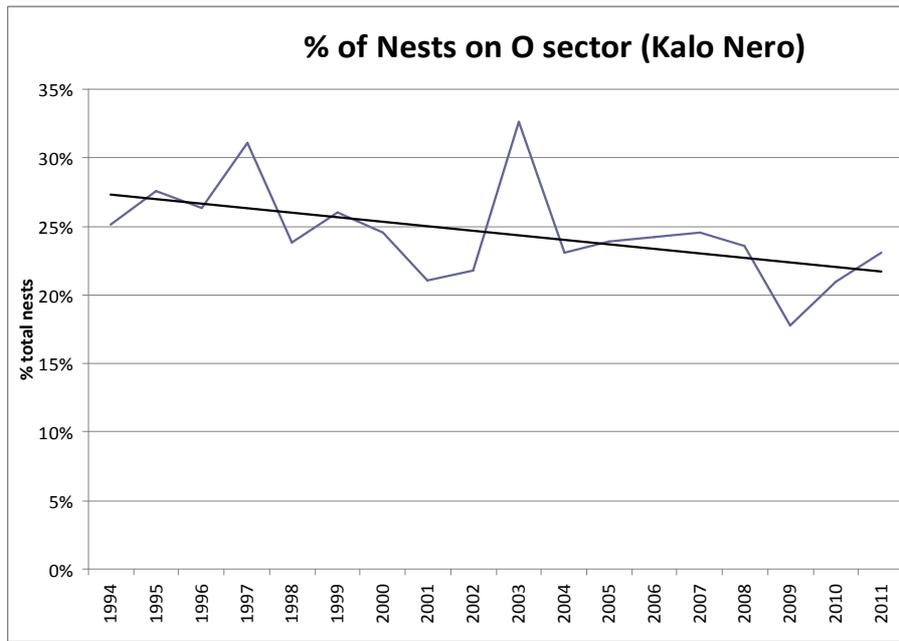
Graph 2. Percentage of nests in O Sector in comparison to total nests in core area, showing a declining trend over the years 1994-2011.

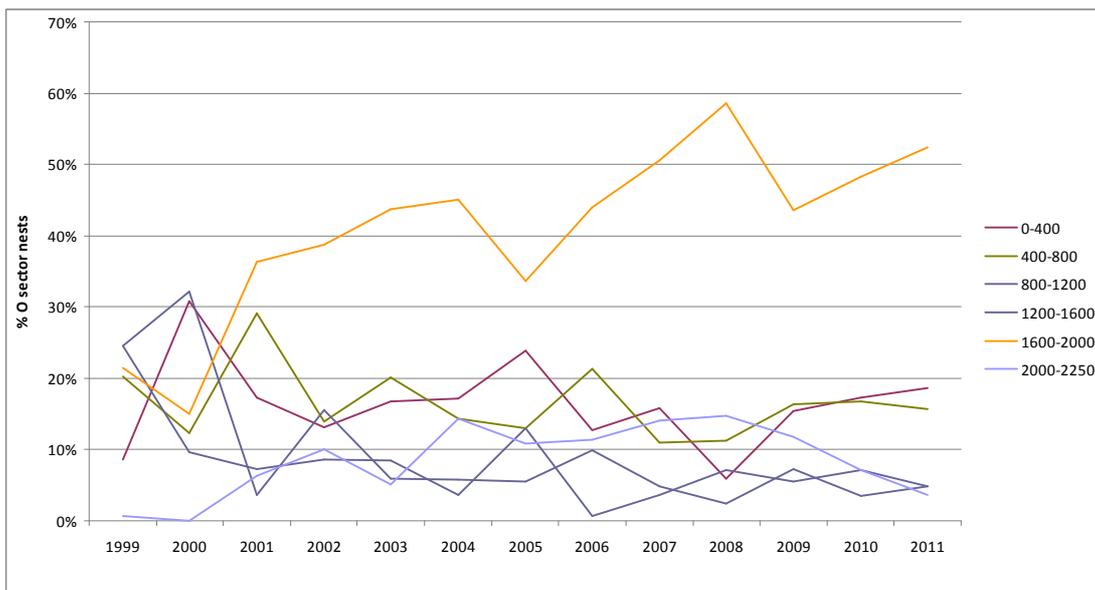
Graph 3. Percentage of nests over specific locations in O Sector (Kalo Nero). The orange line shows that a 400m beach section (between 1600 & 2000m from the start of the beach) without beach-bars now has a significantly increased proportion of nests. Prior to the existence of these bars, nest locations were fairly uniformly spread, whereas now almost half of the nests at Kalo Nero beach are in this quiet area - one of the few quiet areas remaining in the village.
